RWANDA WATER AND FORESTRY AUTHORITY

ANNUAL WATER STATUS REPORT 2016-2017

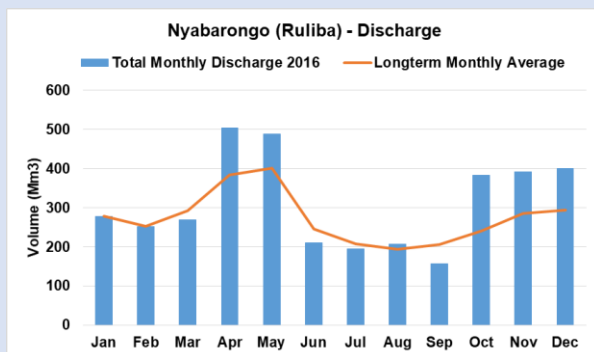
Data Source: RWFA/IWRMD

The flow of the Nyabarongo River at Ruliba (see below) reached the highest level during the early wet season (April-May) showing the influence of heavy rainfall., However, the flow was gradually decreased from June to september.

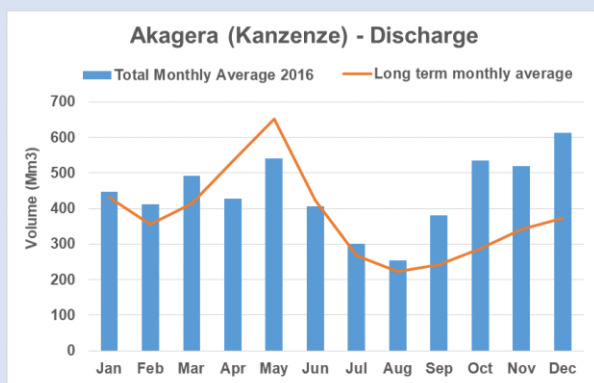
Data Source: RWFA/IWRMD

The flow of the Akagera River at Kanzenze (see below) during the 2016 wet season was significantly below the long term average whilst the remaining period flows were above the long term average. As the Kanzenze station receive flow for Akanyaru river as another input, there is a chance of low flows due to lowest rainfall occurred in upstream part includes also a part in Burundi.

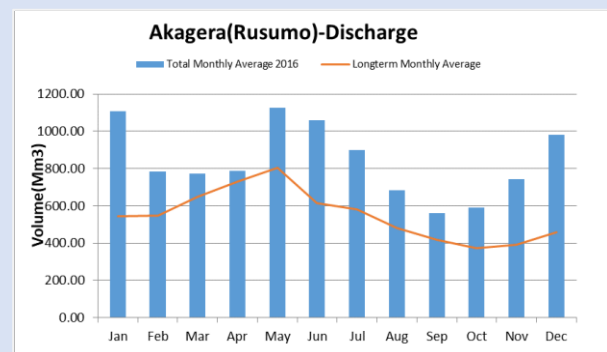
Data Source: RWFA/IWRMD

The flow of the Akagera River (bordering Burundi and Tanzania) at Rusumo (see below) in 2016 was higher than its long term average due to the influent inflows from the upstream reaches.

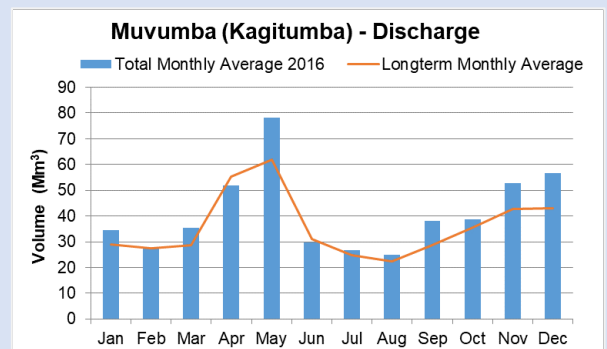
Data Source: RWFA/IWRMD

The flow of the Muvumba River (bordering Uganda) at Kagitumba (see below) in 2016 was higher in May than its long term monthly average and the rest of the months are below .

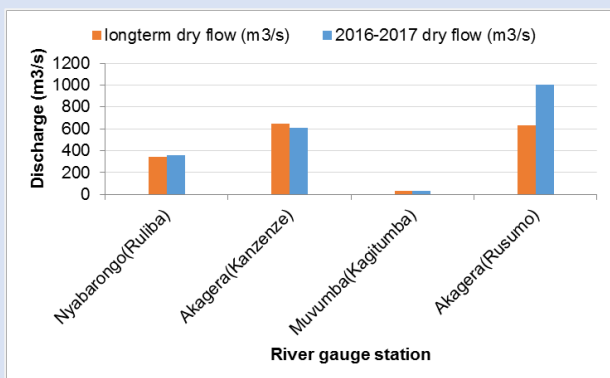
Data Source: RWFA/IWRMD

The flow discharge from Nyabarongo river, Akagera river and Muvumba river, with four main gauge stations: Ruliba, Kanzenze, Kagitumba and Rusumo gauge stations respectively (Figure below). The results show no significant change in monthly dry discharge 2016-2017 and longterm dry months at the Nyabarongo lower, Akagera upper and Muvumba river. Changes of dry monthly discharge at the Akagera lower(Rusumo station) are evident, and other flow from Burundi appear to be responsible for the seasonal variation of flow discharge.

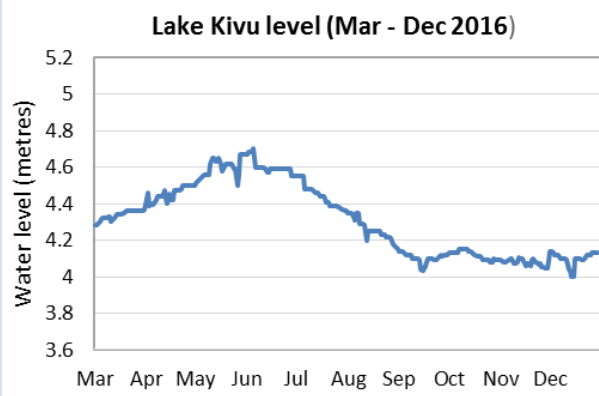
Data Source: RWFA/IWRMD

The water level of Lake Kivu (see below) is also being recorded. Data for 2016 shows that lake levels are at the highest during May and June before dropping by 0.7 metre towards september. This seasonal variation is typical for Kivu and reflects the rainfall patterns, it is also reservoir water releases from rusizi hydropwer controls over the flow of the Rusizi River.

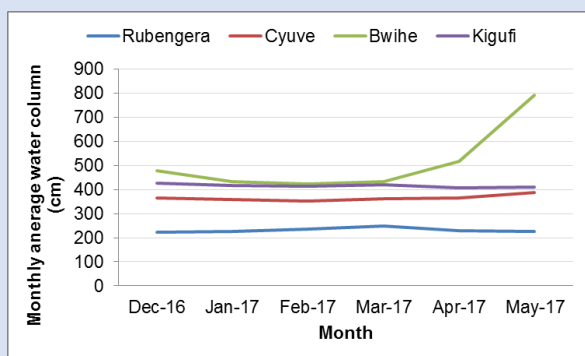
Data Source: RWFA/IWRMD

The graph below shows the water column variation in groundwater monitoring boreholes located in Musanze, Karongi and Rubavu.

The borehole of Bwihe site located in Karongi (Figure below) indicates high variation due to the water abstraction from the nearby spring. For other three boreholes, the variation is not significant and

may be due to their location covered by stagnant water for long period and water table is often close to surface.

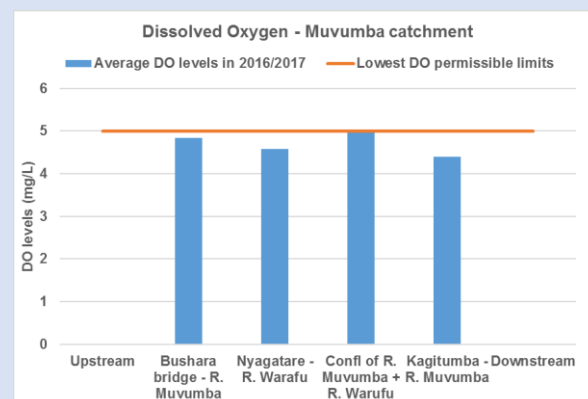
Data Source: RWFA/IWRMD

However, DO levels crossed the lowest allowable threshold of 5mg/L for different sites considered in Muvumba catchments and on key hotspots as indicated by the figures below:

Except for sampling sites at the confluence of the Rivers Warufu and Muvumba, DO levels in Muvumba catchment were found below permissible limits at almost all points sampled which indicates deterioration water quality by oxygen consuming pollutants.

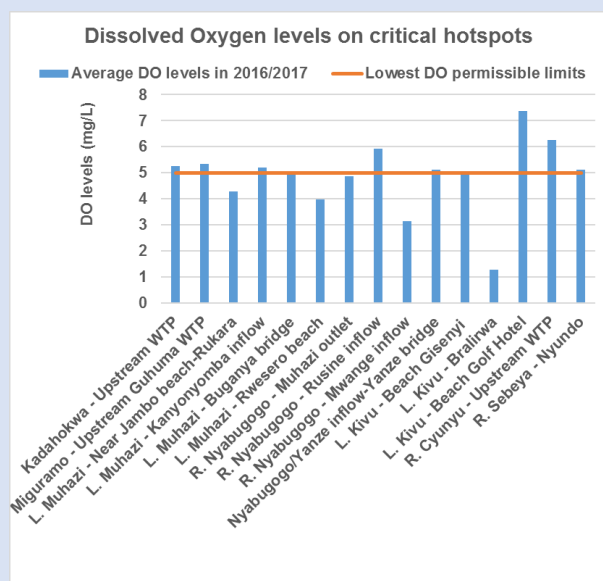
Data Source: FWFA/IWRMD

Similarly, several locations are deemed 'Hotspots', either due to their importance as bathing sites, water abstraction points (upstream of Water Treatment Plants – WTPs) or in relation to noted polluters recorded DO levels below permissible limits. This is the cases of Lake Kivu near the Bralirwa brewery site, Lake Muhazi and River Nyabugogo

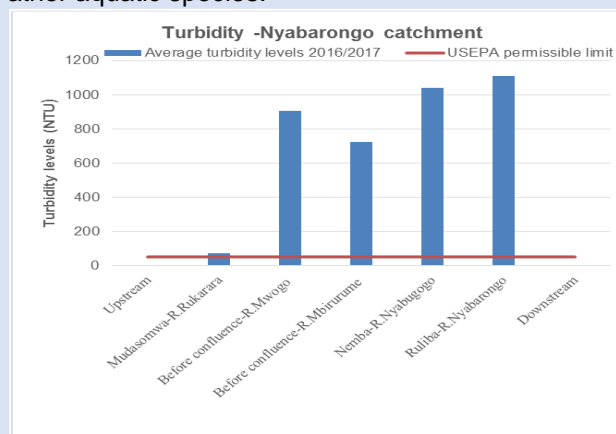
Data Source: RWFA/IWRMD

Turbidity levels were found to be high in most of the catchment considered, compared to a highest turbidity limit in ambient surface water of 50 NTU (US EPA). Turbidity in surface water can have adverse effects including inhibition of photosynthesis, reducing aquatic plant and algae growth as well as reducing visibility for fish and other aquatic species.

Except for River Rukarara which slightly crossed the permissible turbidity level, turbidity levels at the other sites significantly crossed that permissible limit.

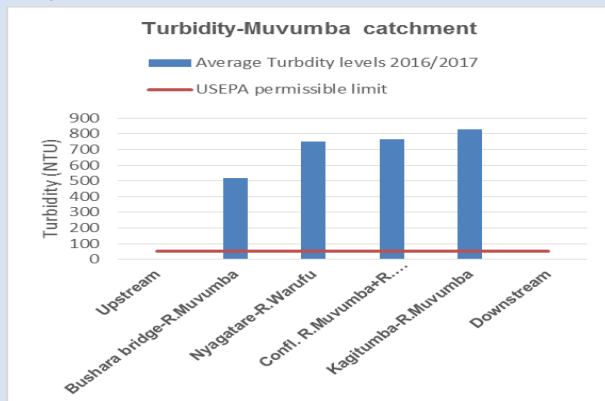
Data Source: RWFA/IWRMD

Turbidity levels in Muvumba catchment were found high compared to US EPA threshold of 50 NTU in stream waters

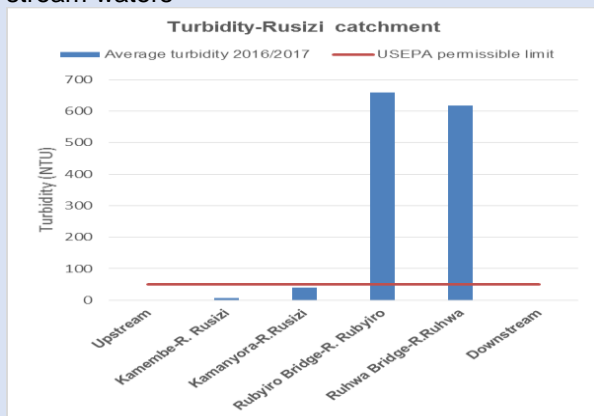
Data Source: RWFA/IWRMD

Rubiro and Ruhwa rivers recorded highest turbidity levels, exception to Rusizi River at Kamembe and Kamanyara which recorded turbidity levels below US EPA threshold level.

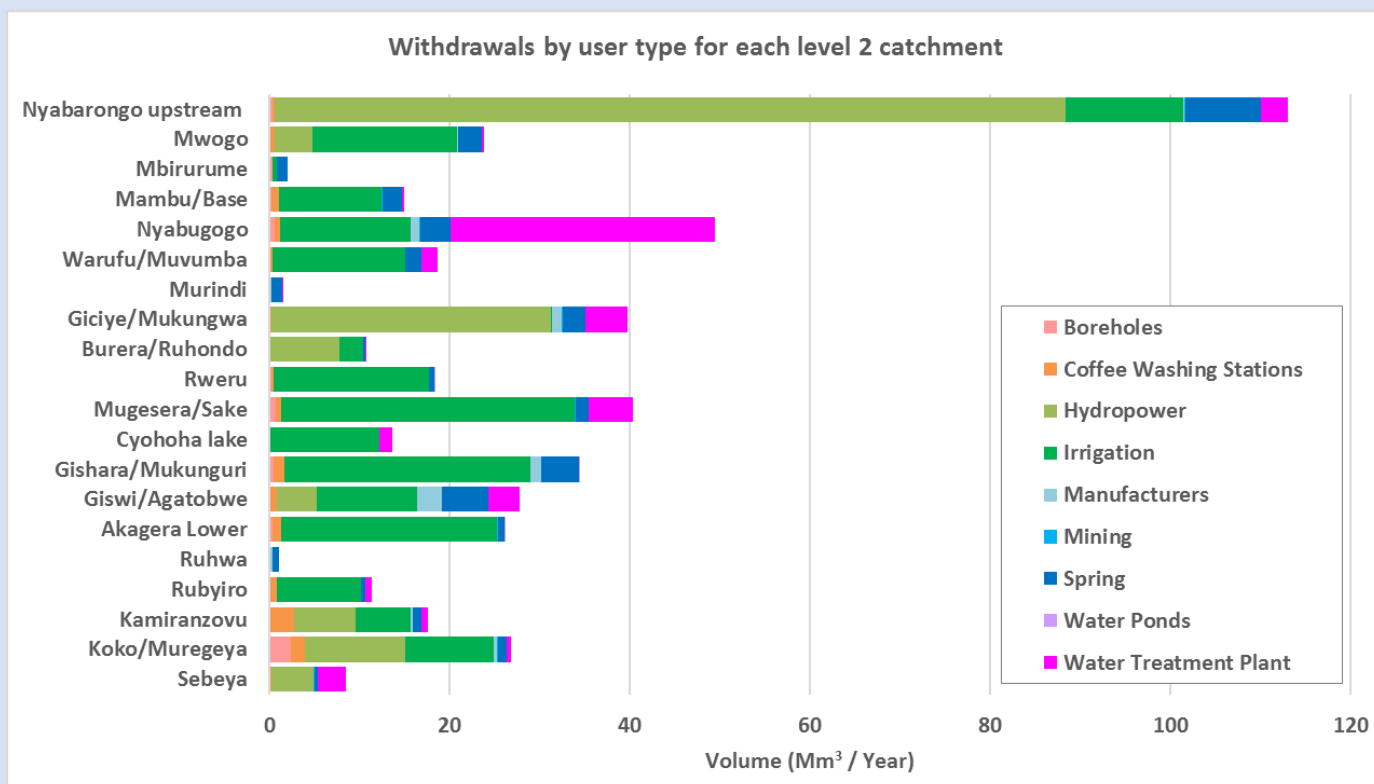
The Nyabugogo sub-catchment is dominated by water treatment (domestic supply in and around Kigali) and irrigation, whilst hydropower dominates the upper Nyabarongo and Mukungwa catchments. Additionally, irrigation is by far the largest single consumptive user (222 MCM or 45%) with a wide spread across the catchments.
