REPUBLIC OF RWANDA

Ministry of Environment

Erosion Control Mapping Report

February 2020

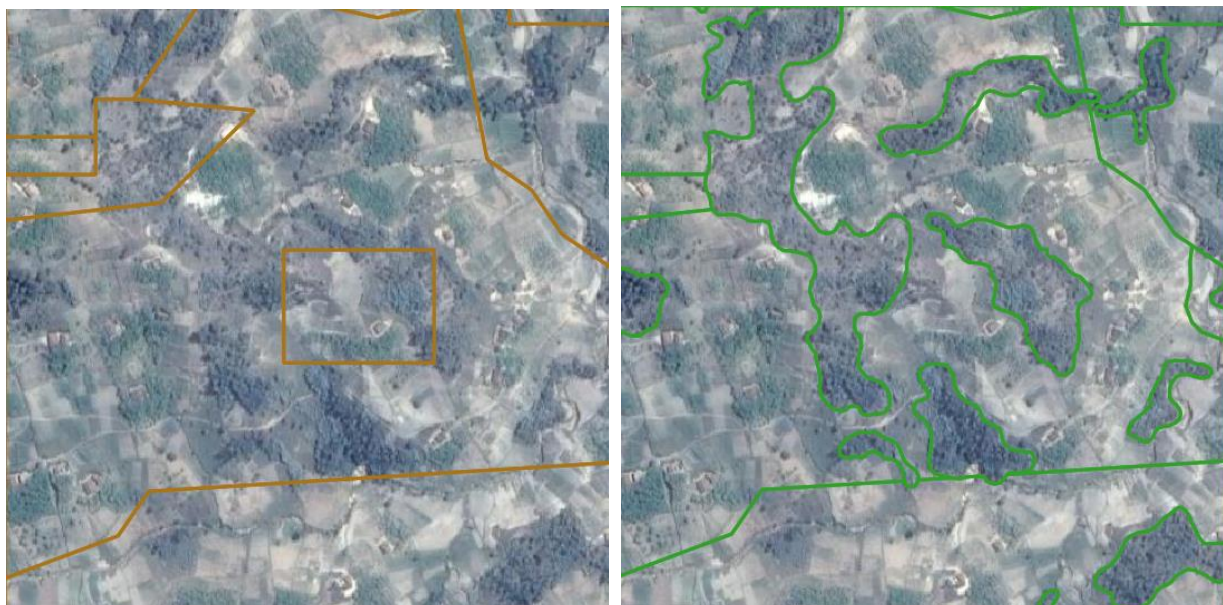
The 10 GIS technicians were organized in two team working in respectively day and night shift. Each computer had a connection to Digital Globe online images. Their tasks were to identify and interpreting the erosion feature types, the erosion control techniques in place, the land cover types and proposing adequate measures for mitigating the identified erosion risk. Technicians had to clean or edit polygons geometry if they find that the feature is not well demarcated. This consisted of either reshaping the polygon or completing it by adding a missing part of the identified erosion feature. Below is an illustration of the editing method showing the polygons shapes before (a) and after (b) the editing process.

(a)Before editing

(b) After editing

This method consists of correcting polygons geometries, completing polygons and adding attributes in the polygons attributes table. Very high resolution World View images (30-50 pixel size) of recent years (2018-2019) were used as basemap to check and using on-screen digitising techniques delineate different erosion risk features, land use and vegetation cover, erosion control techniques in place and recommendations of erosion control practices based on land uses.
